TROUBLESHOOTING TIPS FOR THE 4R44E & 5R55E

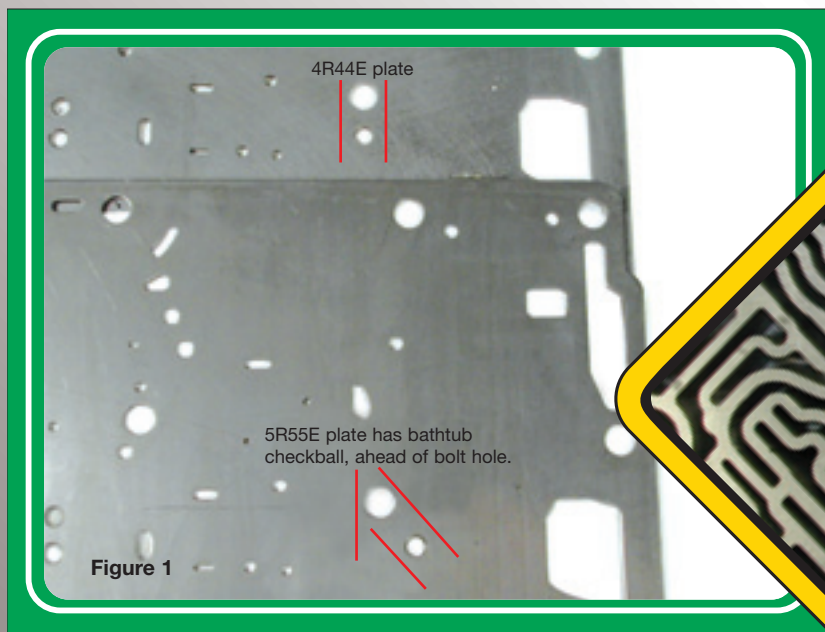
Don't assume that because of the changes and many part numbers, your valve bodies remain selective. By following our instructions you can obtain 100% application for both units. *Figure 1* identifies the 5R vs. 4R separator plate. After rebuild, the casting can be used for either a 4R or 5R unit.

Mismatched separator plate at 5R/4R identification (*see Figure 1*).

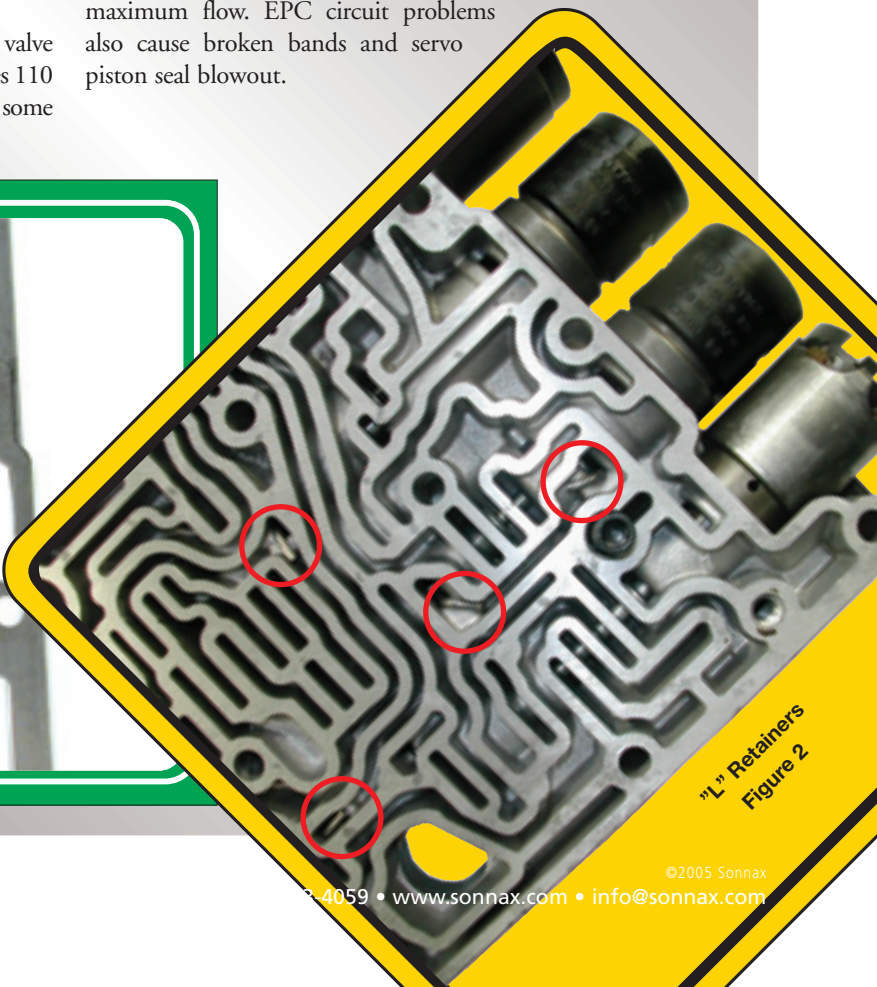
When you examine this valve body (see *Figure 2*), you see the many “L” retainers. These locate and hold plugs, which separate and seal oil circuits. As the valves toggle, the plugs become loose and allow fluid to pass around them. In the past, some end plugs could be ridged or knurled to reduce oil loss, but in this casting, it's not possible, due to their depth in the bore and the close fitting tolerances. In newer versions, plugs are anodized and cannot be altered. As these toggle, they wear the casting and not the plug.

Loss of certain gears can occur due to issues in at least two other circuits. Loss of solenoid oil due to end plug leakage can cause no reverse, and loss of 3rd or 4th and can be repaired with **37947-13K**. Leakage at the coast clutch valve can result in loss of 4th, 5th, or engine braking: you can eliminate leakage with **37947-33K**.

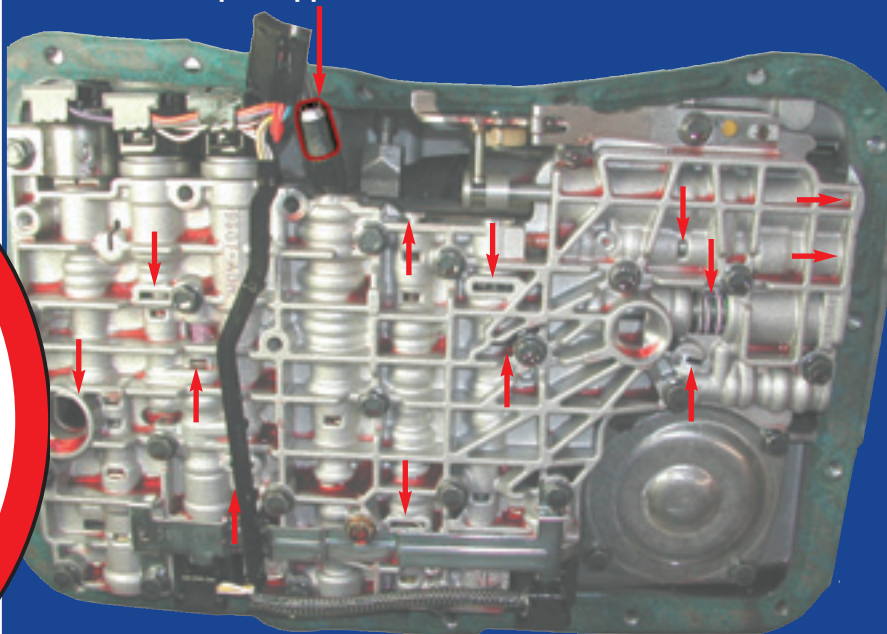
Figure 4

Besides the plug and retainer issues, bore wear, as illustrated in the product announcements in this catalog and indicated by the arrows in *Figure 4*, add to the complaints. With the interdependence of circuits on overall control, it's not practical to patch-fix this body. For example, delayed engagement is not related to the TCC regulator valve and high TCC slip is not fixed by enlarging a line-to-lube hole. Modifying valve control generally results in shift quality that will not meet customer expectations.

Supply 50-70 psi of air into the adapter. No leaks should be visible at the locations shown in *Figure 4*. Any leakage is reduction of EPC pressure and line rise while in operation. Remember, though, as operating temperature increases, valve clearance and the flow rate (viscosity) of ATF increase. You can duplicate hot fluid at the bench by filling the case and valve body with solvent, then bolt up and test with the adapter.

“Tired” valve bodies leak at any or all of these locations.

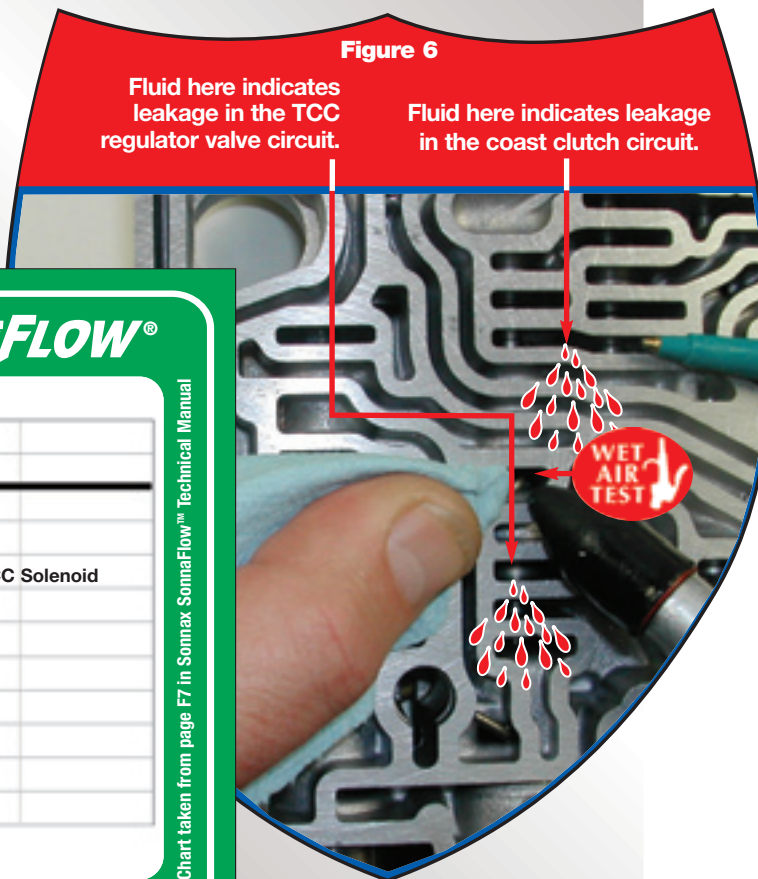
Figure 6

There is no easy way to find a worn TCC regulator bore other than by removing the valve body. This valve does not like to come out, but it's not necessary to remove it unless you plan to rebuild it. We supply the disassembly procedure. This valve can be Wet Air Tested as shown in Figure 6. Fluid leakage below the nozzle, back toward the solenoid, indicates a leak in the TCC regulator valve circuit.

and 5th in the 5R unit. If it sticks, the coast clutch will not apply. This wear can be found on a hydraulic test bench or with the Wet Air Test in Figure 6. Fluid coming out of the channel indicated by the pen tip indicates leakage in the Coast Clutch valve circuit.

Fluid here indicates leakage in the TCC regulator valve circuit.

Fluid here indicates leakage in the coast clutch circuit.

Inspect the bore plug for wear at the TCC regulator valve. Sonnax **37947-09K** kit eliminates the leak and bore plug here. The bore for the coast clutch shift valve wears out. Insert the valve: no side-to-side movement should be visible.
