TROUBLESHOOTING TIPS FOR THE 4R44E & 5R55E

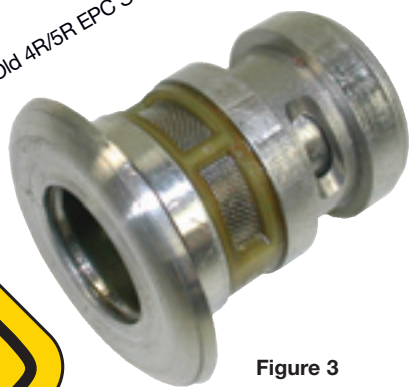
Figure 3

case. This can be done in the vehicle or at the bench. A quick test adapter can be made from an old 4R/5R EPC solenoid. The coil housing and valve will be removed and a plug or epoxy used to seal the inboard circuit (see *Figure 3*).

Old 4R/5R EPC Solenoid

40-60 psi supplied to modified EPC solenoid/tool

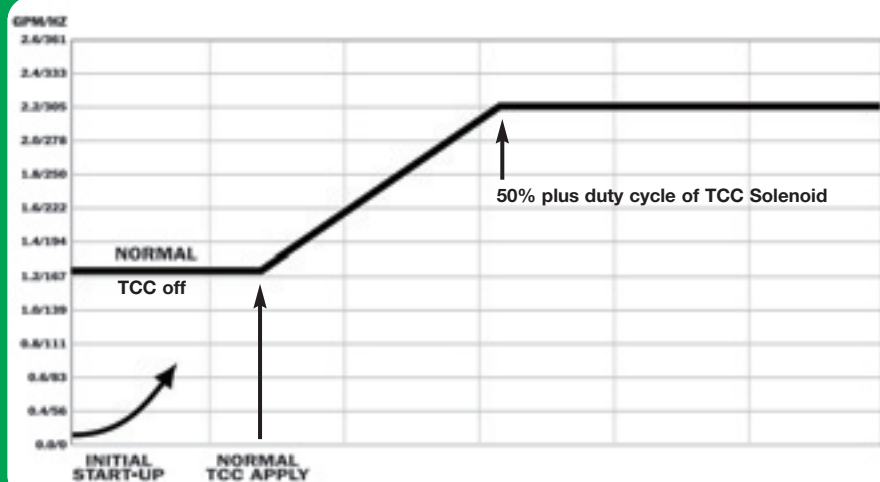
Figure 5

A TCC modulator valve that will not stroke or may have partial stroke can be diagnosed on a road test. The SonnaFlow® must be installed and converter fluid must reach 150 degrees Fahrenheit before the thermal element opens, allowing for external cooler flow. Flow will increase from an average of 1.4 GPM with TCC off, to 2.3 GPM-plus under full apply. The scanner should be used during this drive to monitor TCC duty cycle percentage. As modulation increases to 50%, the solenoid should have fully stroked the TCC modulator valve. When you see the sharp rise in GPM on the Sonnaflow, the valve has fully stroked. If cooler flow does not rise as TCC apply is commanded or the engine stalls upon forward engagement, inspect the TCC solenoid first. If the

4R44E/5R55E ('99)

SONNAFLOW®
